# South Avenue Corridor Action Plan

## **PLAN & ACQUISITION STRATEGY PRODUCED AUGUST 2015**

by the YOUNGSTOWN NEIGHBORHOOD DEVELOPMENT CORPORATION  
and the CITY OF YOUNGSTOWN

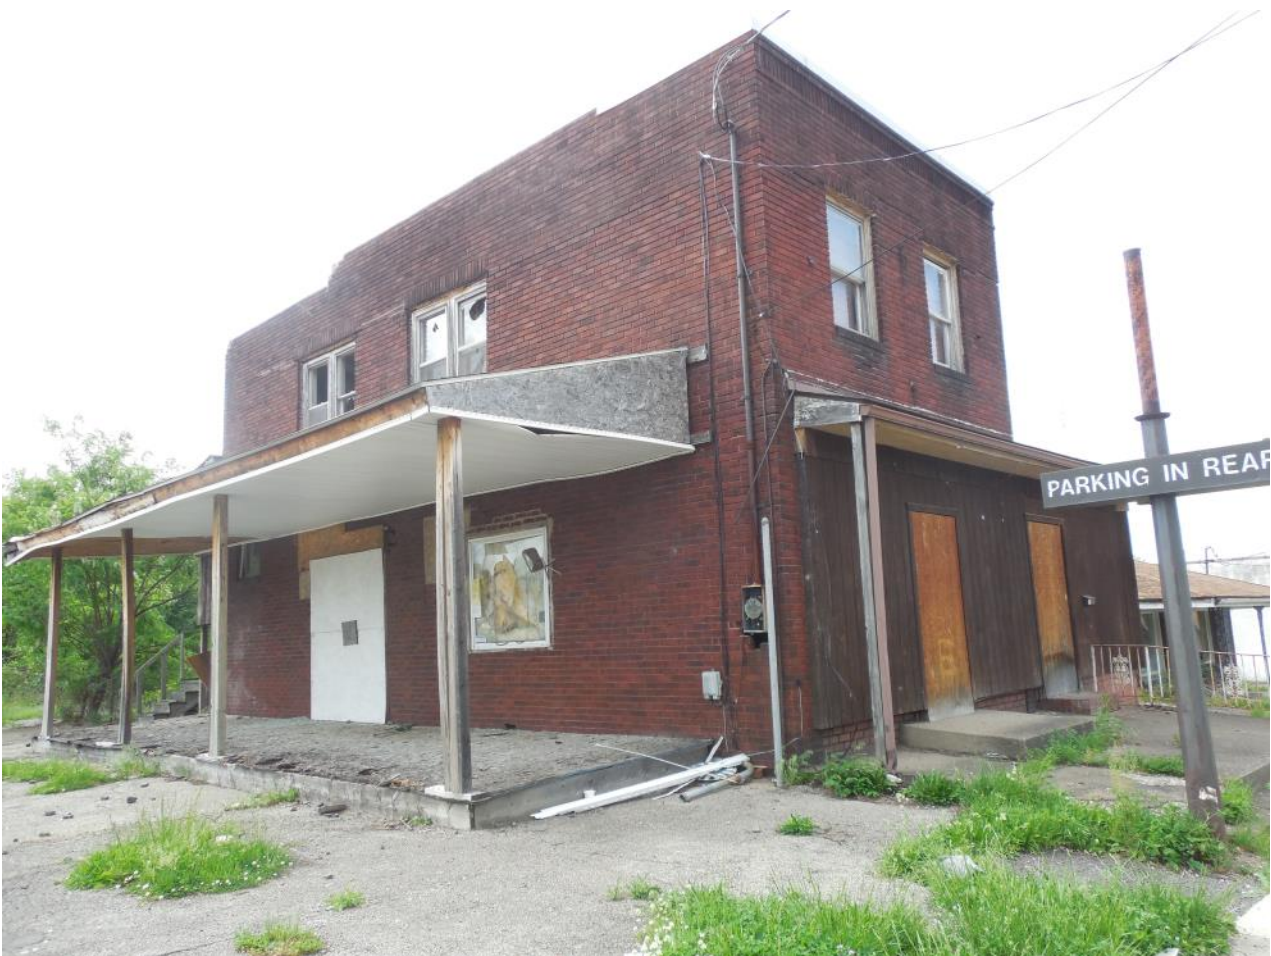
A vacant, blighted structure at 2316 South Ave. has a detrimental effect on the nearby properties and the appearance of the corridor as a whole.

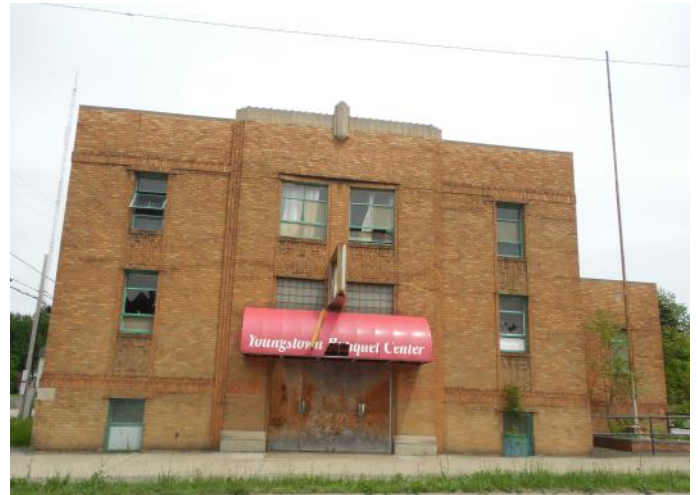
**2205 South Ave: PRESERVATION**

Address	Description of Condition
2205 SOUTH AVE	weeds; unsecure; no premise identification; awning is damaged
1100 SOUTH AVE	boarded; no premise identification; peeling paint; defacement of property

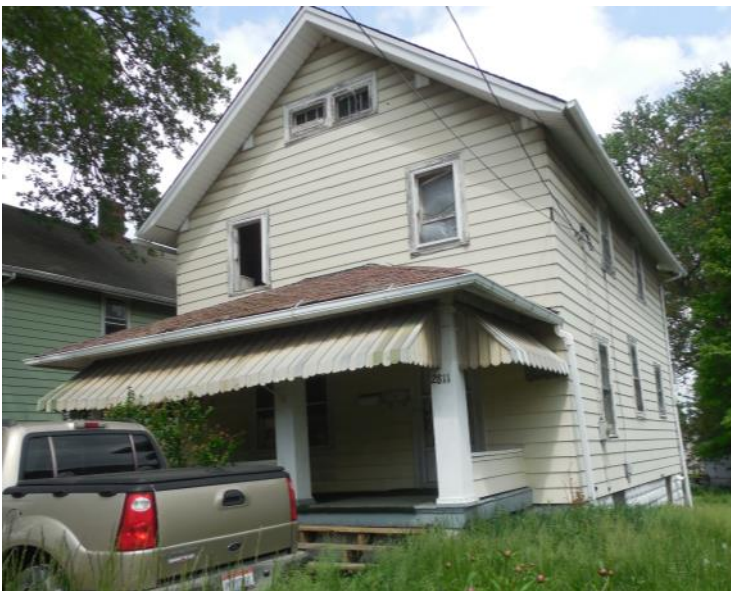
**2811 South Ave: DEMOLITION**

Address	Description of Condition
2811 SOUTH AVE	dumping; weeds; broken window; peeling paint on siding and trim; roof & gutter damage
2724 SOUTH AVE	weeds; roof damage; soffits; boarded
2316 SOUTH AVE	trash/debris; weeds; defacement of property; windows unsecure; roof damage; gutters; downspout; soffits; fascia; holes in porch; partially boarded
2310 SOUTH AVE	trash/debris; weeds; defacement of property; unsecure; roof damage; gutters in disrepair
1111 SOUTH AVE	trash/debris; weeds; dumping in rear; roof damage; no downspout, soffits, or fascia; porch in severe disrepair; boarded
913 SOUTH AVE	broken windows; peeling paint; no gutters, downspouts, soffits, fascia; roof damage; boarded

Address	Description of Condition
2817 SOUTH AVE	trash/ debris; unsecure
2811 SOUTH AVE	dumping; weeds; broken window; peeling paint on siding and trim; roof & gutter damage
2316 SOUTH AVE	trash/debris; weeds; defacement of property; windows unsecure; roof damage; gutters; downspout; soffits; fascia; holes in porch; partially boarded
2310 SOUTH AVE	trash/debris; weeds; defacement of property; unsecure; roof damage; gutters in disrepair
2205 SOUTH AVE	weeds; unsecure; no premise identification; awning is damaged

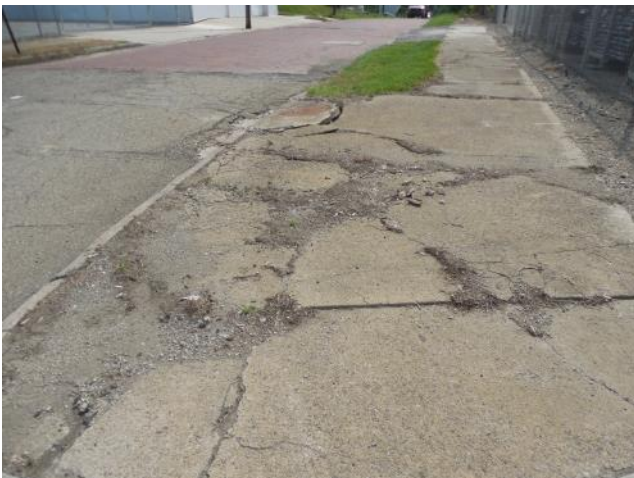
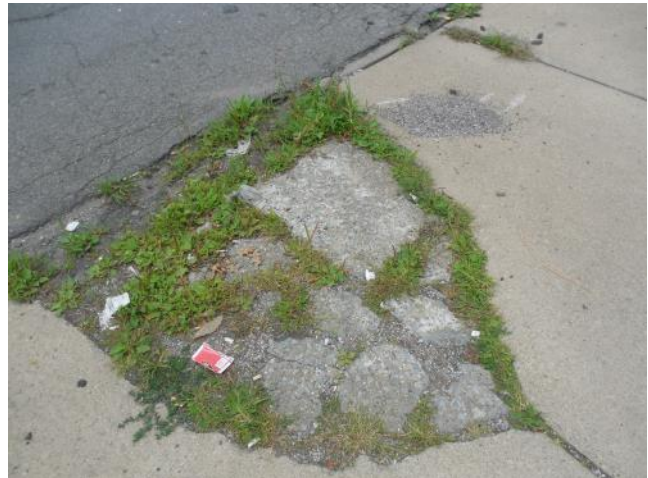
Damaged sidewalks impair walkability and detract from the appearance of the corridor.

**3) Damaged sidewalks should be replaced, with an initial primary focus on areas with a high concentration of businesses, within proximity to institutions, and in areas targeted for pedestrian improvements.** Damaged sidewalks are hazardous to pedestrians and give the corridor an unkempt appearance. Sidewalk improvements should be focused on the southern portion of the corridor, between E. Indianola Ave. and E. Lucius Ave., due to this area's proximity to institutions such as Taft Elementary School and Wilson Middle School.

**4) Overgrown sidewalks should be uncovered and cleaned up at community workdays.** Clusters of overgrown sidewalks exist at demolition sites and areas that have lacked maintenance for years. These sidewalks should be scraped and cleaned of debris and overgrowth in order to enable nearby residents to safely use them. This should be done in conjunction with neighborhood groups, the City of Youngstown's RUBY tool trailer, and Street Department staff.

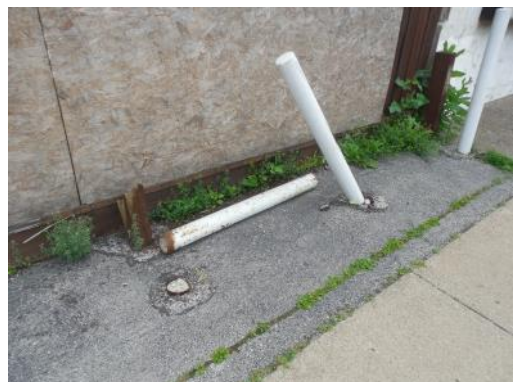
Orphan poles on the sidewalk impair walkability, are a tripping hazard for pedestrians, and give the corridor an unmaintained appearance.

**6) Remove orphan poles, particularly those located in the sidewalk.** Orphan poles constitute a tripping hazard for pedestrians and give the corridor an unmaintained appearance. These should be removed once a determination has been made that they are no longer in use.

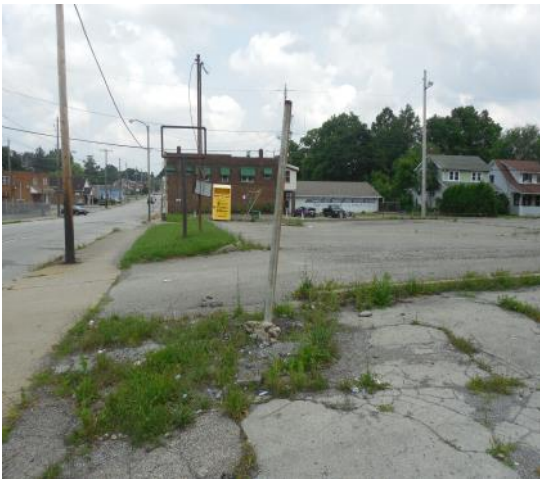
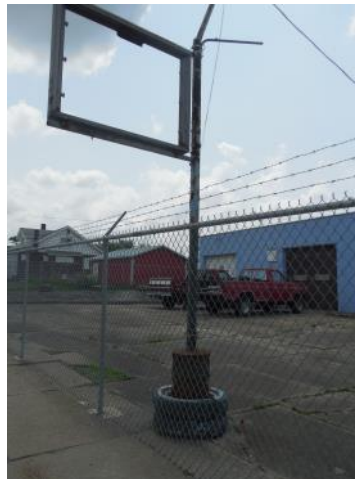
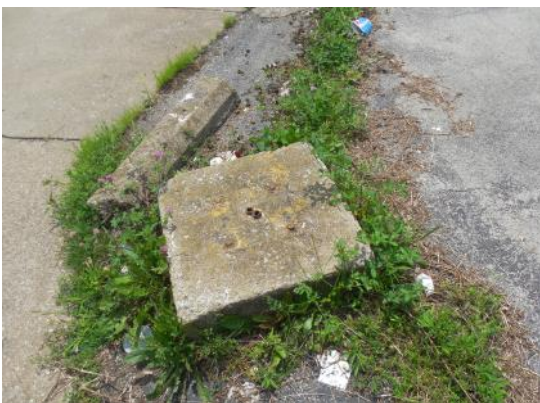
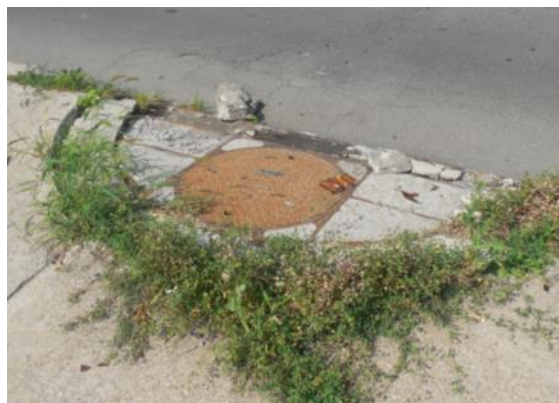
Infrastructure issues along South Ave. give the corridor an unmaintained appearance.

- 1) **Fill potholes and repave streets in poor condition, particularly near the intersections of side streets and South Ave.** South Ave. itself has serious potholes and patches, and is in need of resurfacing. In addition, the adjacent streets have many issues that need to be addressed as well.

- 3) **Rebuild deteriorated “aprons” along the corridor or remove where no longer needed.** Aprons are the entrances to driveways and parking lots between the street itself and the sidewalk. Many of these along South Ave. are in poor condition and should be rebuilt to improve the appearance of the corridor and to provide easier access for both motorists and pedestrians.

- 4) **Replace or remove damaged street signs along the corridor.** Damaged street signs detract from the corridor’s appearance and can be hazardous to motorists who rely of the sign’s information to safely navigate the corridor.
